Geotechnical Investigation Report on a land proposed for the construction of a three (3) Storey Hostel Facility at the University of Cape Coast, Cape Coast

A report Prepared by Gyamera, E. A, and Donkor, N.

Department of Soil Science, School of Agriculture, University of Cape Coast, Cape Coast. Ghana.

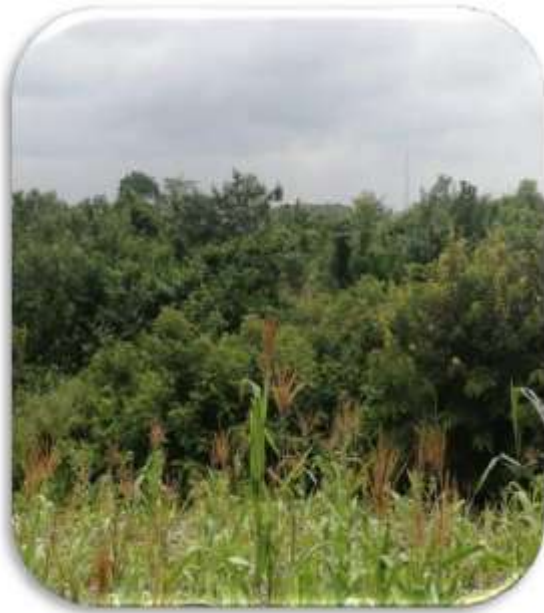
Figure 2.1: Northside site view with trees and shrubs with maize farm

The allocated site for the proposed project is located about 100 meters from the Kwame Nkrumah Hall and located on a 30-acre land. The site is covered with trees and shrubs as indicated in the Figures 2.1 and 2.2 below.

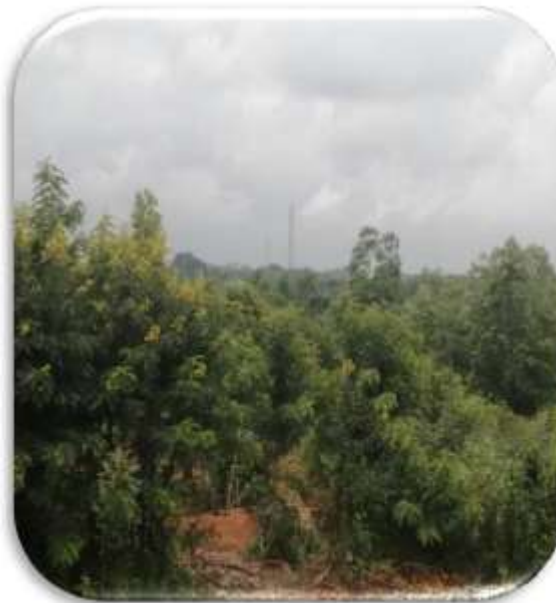
Figure 2.2: Northwards interior view of site with tree and shrubs

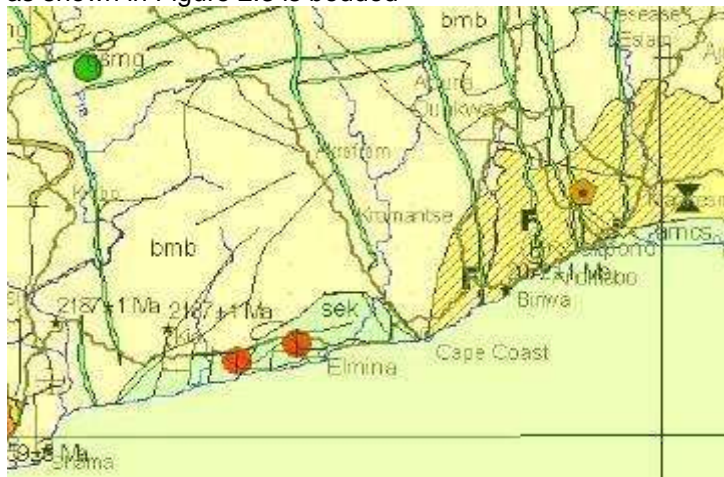
**Figure 2.3: Geological location of University of Cape Coast**

on mainly on protolithic Birimian super rock with some overprint of metamorphic properties. The formations are composed mainly of biotite gneiss and minor components of biotite schist with some garnet and amphibole minerals and in some cases without. As known, rocks with protolithic characteristics and coarse-grained metamorphic rocks are generally stable and strong and their decomposition may result in residual sandy and gravelly soils.

Cape Coast as shown in Figure 2.3 is bedded

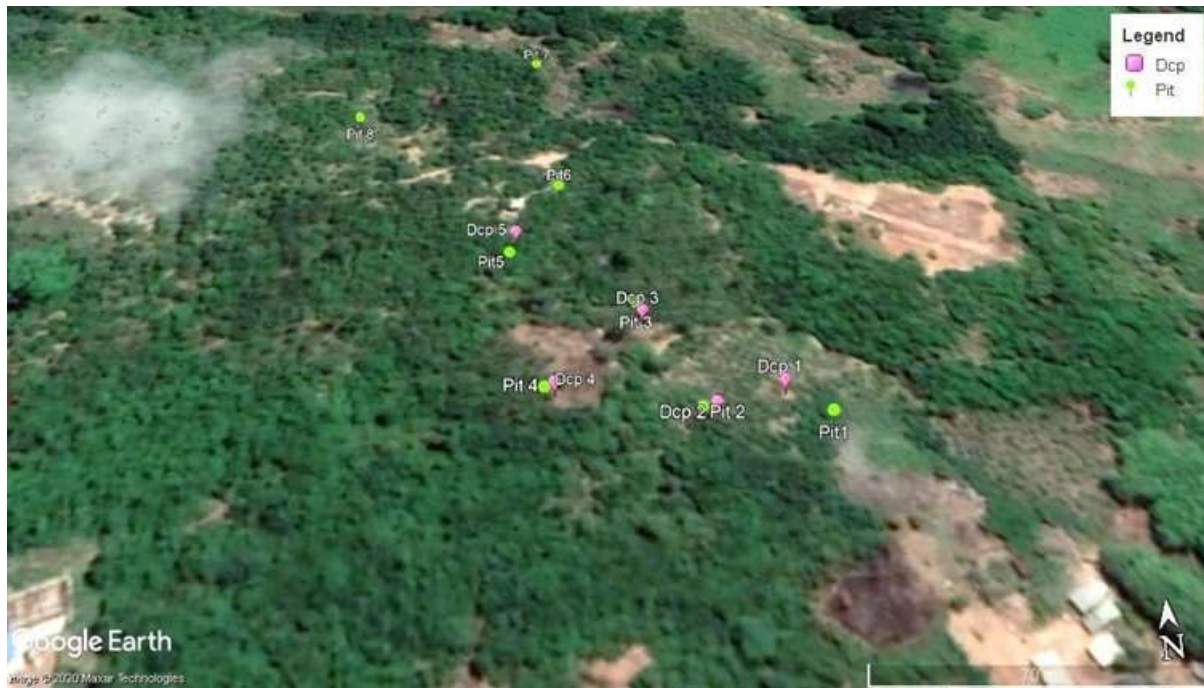
Figure 3.1: Layout of site with DCP test spots and trial pit

Fieldwork was undertaken on the 25th of July 2020 and was carried out in accordance with BS 5930. The activities comprised of the DCP (DIN 4094) test and trial/test pitting. The location of the pits and DCP points were selected to cover the section of the land allocated for the proposed project. GPS locations of the pits and DCP spots were recorded and displayed in Figure 3.1.

LOCATION OF TRIAL PITS AND DCP TEST POINTS

ITEM	LONGITUDE	LATITUDE
PIT 1	1°16'47.73"W	5° 7'3.90"N
PIT 2	1°16'48.74"W	5° 7'4.01"N
PIT 3	1°16'49.09"W	5° 7'5.22"N
PIT 4	1°16'49.93"W	5° 7'4.31"N
PIT 5	1°16'50.12"W	5° 7'5.96"N
PIT 6	1°16'49.61"W	5° 7'6.84"N
PIT 7	1°16'49.69"W	5° 7'8.86"N
PIT 8	1°16'51.52"W	5° 7'8.11"N
DCP 1	1°16'47.98"W	5° 7'4.26"N
DCP2	1°16'48.57"W	5° 7'4.06"N
DCP 3	1°16'49.00"W	5° 7'5.13"N
DCP 4	1°16'49.80"W	5° 7'4.36"N
DCP 5	1°16'50.00"W	5° 7'6.24"N

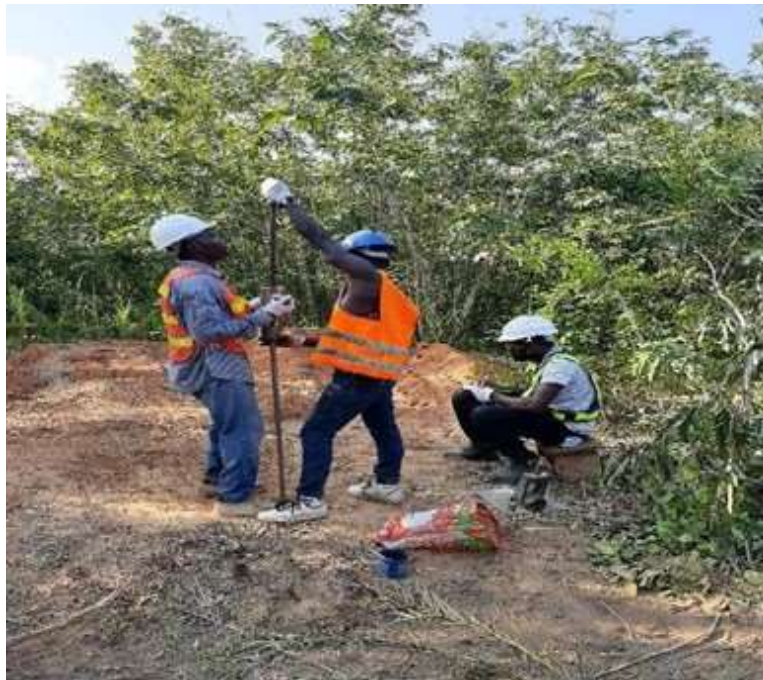
Figure 3.2: Sinking of DCP 1 at the site

A total of five (5) number Dynamic Cone Penetrometer tests were conducted with the Lightweight Dynamic Cone Penetrometer (DIN 4094) to assess the soil strength or bearing capacity at varying depth. Each DCP test was terminated at refusal or when over 50 blows per 100mm was achieved. Figure 3.2 shows DCP being sunk.

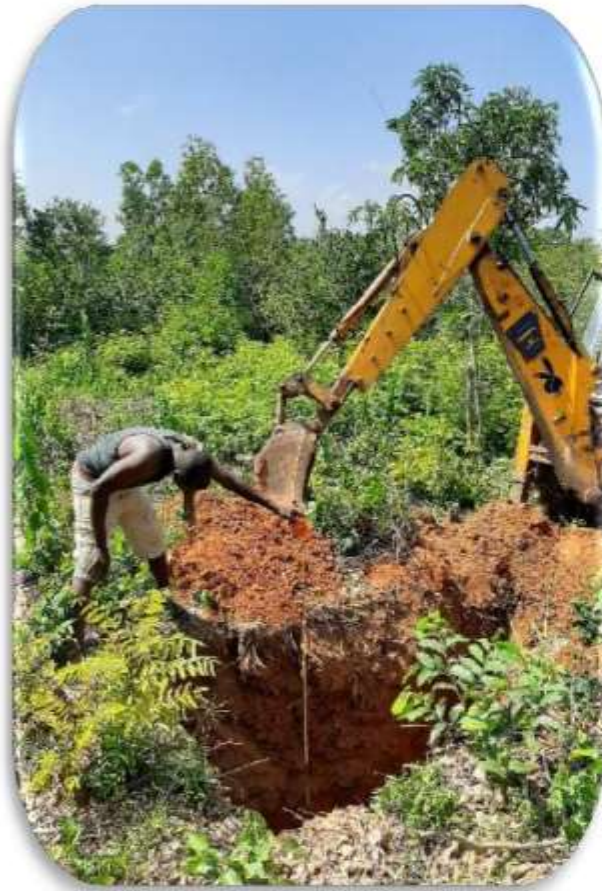
Figure 3.3: Trial pit being sunk

Eight (8) test pits of an average area of about 2.5m² each were excavated with a backhoe as shown in Figure 3.2 and terminated at varying depths. The test pits revealed the soil profile and subsurface soil characteristics. Disturbed soil samples were recovered for laboratory testing as shown in Figure 3.3 and 3.4. Groundwater was not encountered in all the pits excavated.

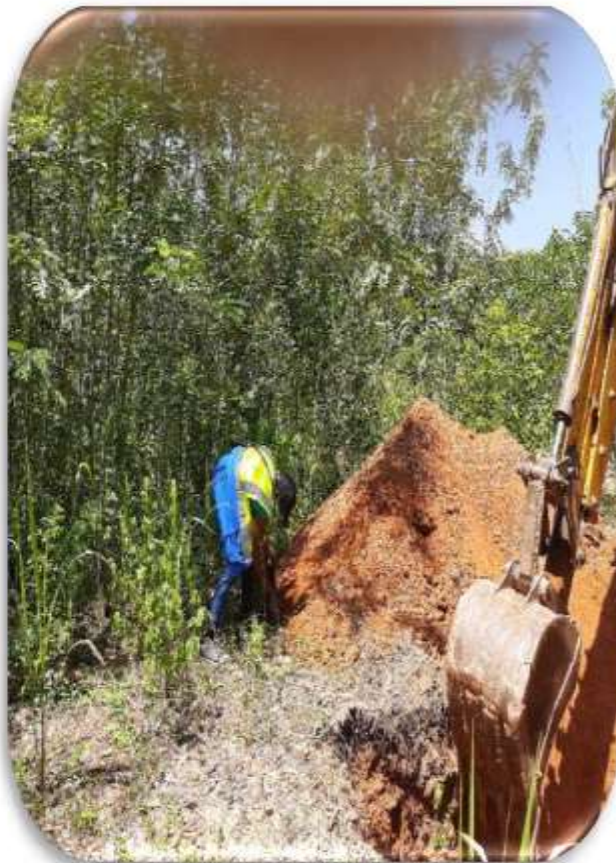
Figure 3.4: Material sampling in the excavated
