# Community Based Participatory Gully Rehabilitation with Double Post Brush Wood Check Dams and Vegetative Resources Dangur District, Northwestern Ethiopia

Ethiopian Institute of Agricultural Research, Pawe Agricultural Research Center, Ethiopia

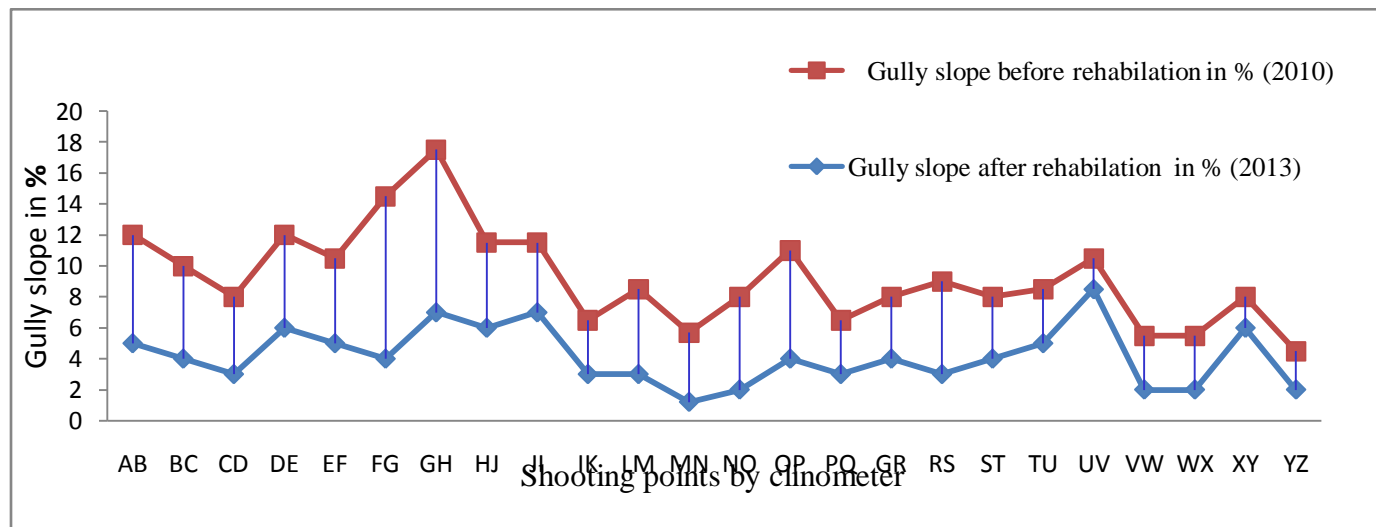
**Gully Slope:** starting from down to upland the gully channel was measured by clinometers to determine the gully gradient. Before intervene (2010) its average gradient was 5% or 2.9° whereas later than (2013) it reduced to 4% or 2.3° due to integration of mechanical double wood posts check dams with biological stabilizing of gully bed channel, gully slide side bank and stopping scouring gully heads and reduces the speed of concentrated run-off and deposited sediment in face to check dams as shown Fig 3. The result agrees with works Nyssen et al. (2007), discovered reduce the slope gradients by breaking the gully section into shorter slope lengths, retain sediments.

Figure 5: Gully gradient difference before and after rehabilitation

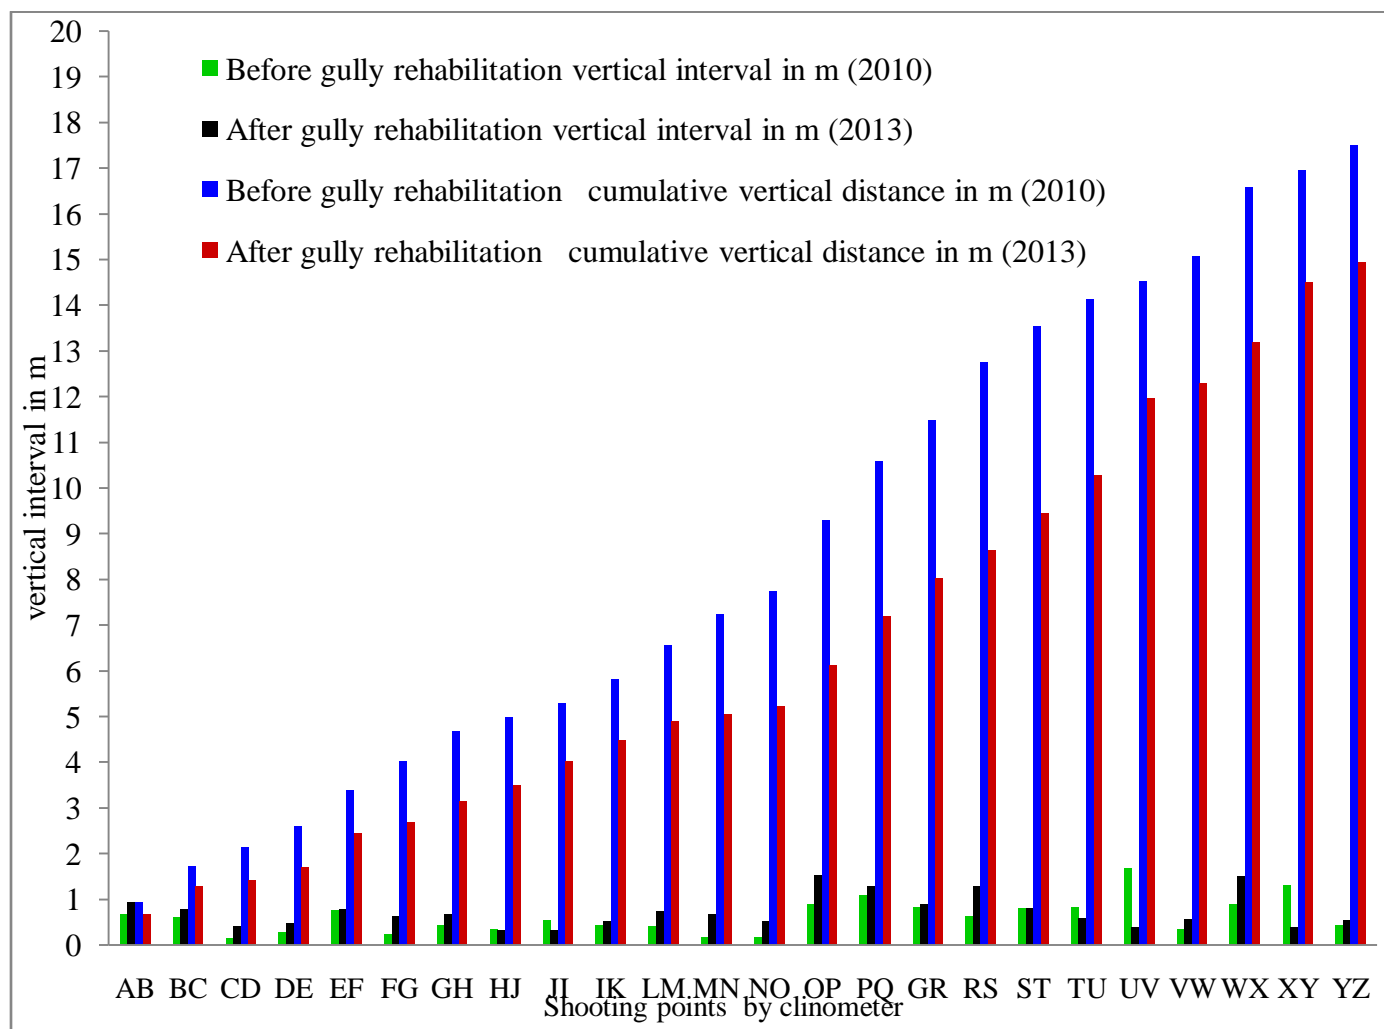
The former mean each shooting points VI was 0.729m while after treated the gully VI reduced in to 0.623m in 2013. The result showed that gully longitudinal channel decrease the gradient slow flow run-off that leads sediment materials deposited and encouraging regenerating vegetative resources at end sodding gully channel. The same to, cumulative vertical distance of gully in 2010 was 17.50m but after intervention its vertical distance reduced to 14.94m in 2013 as shown **Figure 4**.

**Figure 6:** Gully rehabilitation on impact gully vertical interval and cumulative vertical distance

**Gully Vertical interval and cumulative:** Before gullied land treated gully bed channel and vertical interval was measured, the commutative gully vertical interval was calculated by applying trigonometric law equation  $VI = \sin\theta * GD$

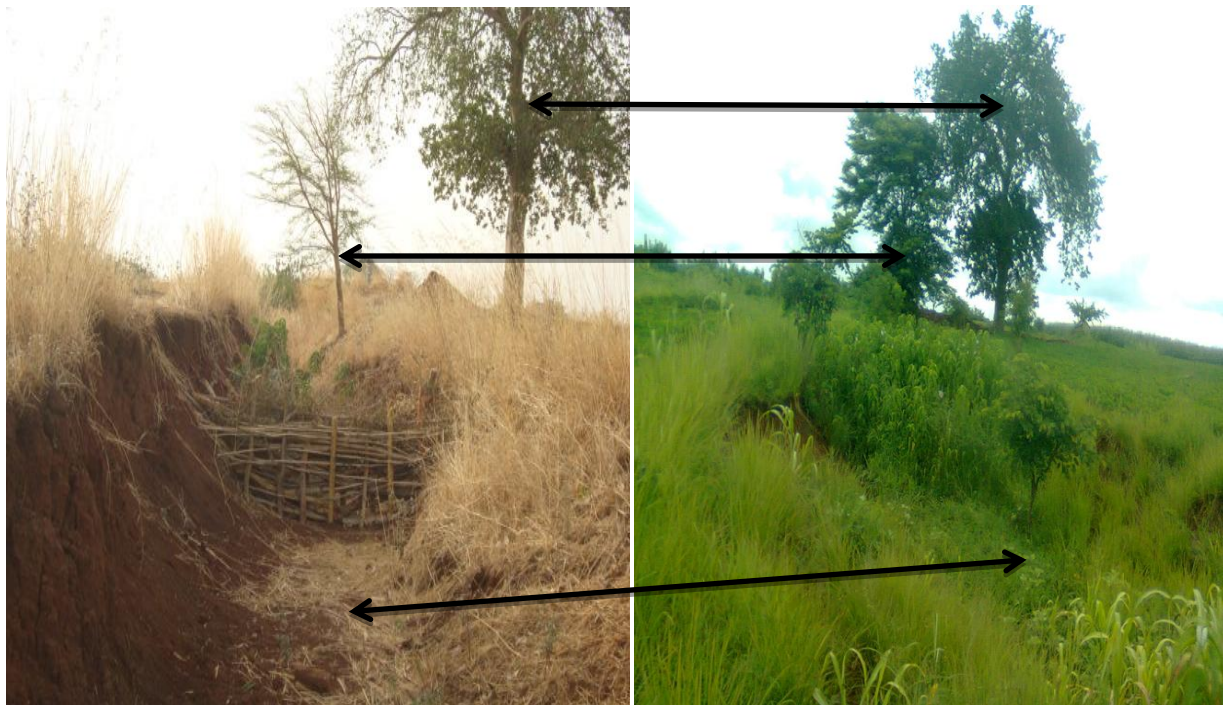
Figure 8: Shows the difference between before and after gully rehabilitation the same site

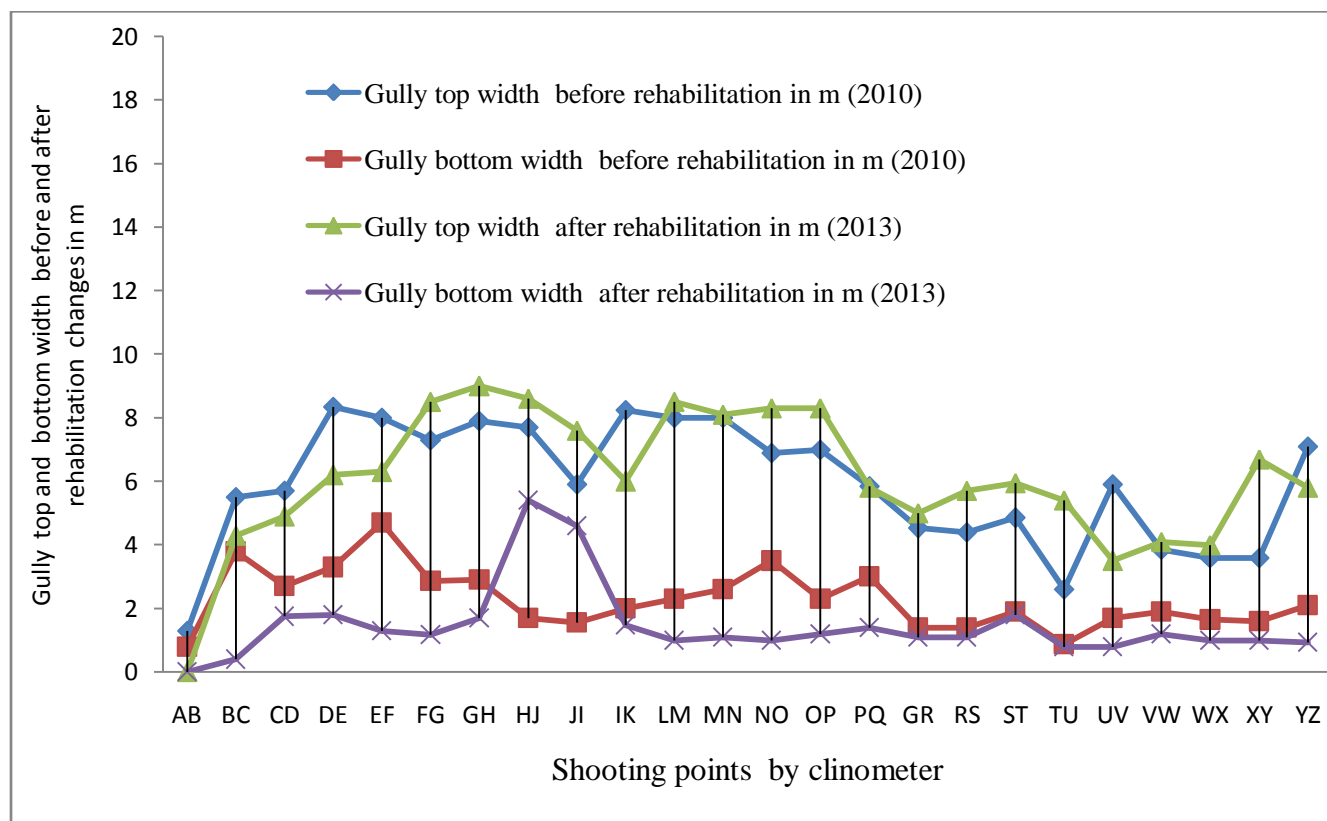
Before treated (2010), the average gully top and bottom width were 5.92m and 2.27m, respectively, while after rehabilitation (2013), its average top and bottom width became 6.11m and 1.46m, respectively. These

measurements indicate that gulling top width increased because vertical gully wall were converted into gentle slope in order to convenient for planting vetiver grassto stabilized gully wall.

**Figure 9:** The relative positions, widths (top and bottom) and depths of gully segments compared before and after rehabilitation (2010 - 2013).

**Gully volume:** The eroded volume gully was calculated using the cross sectional area and its longitudinal length. Thus, before intervention the volume gully was  $2,995.41.38\text{m}^3$  where as in 2013 gully accumulated sediment yield  $1,515.5\text{m}^3$  soils the volume of gully reduced in to  $1479\text{m}^3$  as Figure 8.

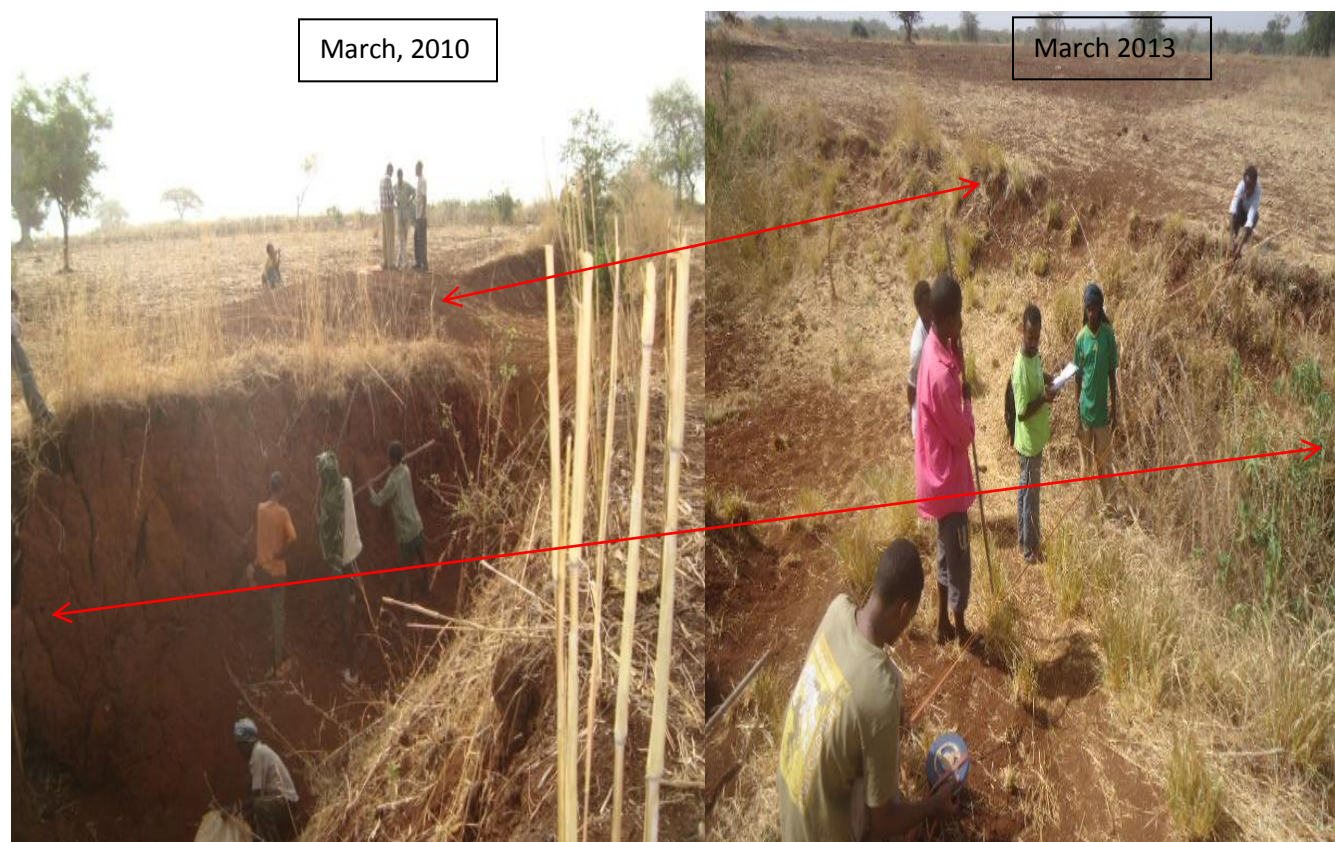
Figure10: shows the deference between before and after gully rehabilitation the same site and season.
