A Report

Groundwater Drilling Report on komenda Sugar Factory

Seftec India Ghana Limited engaged Pekwapong Company Limited Under The Supervision Of Gyam Engineering And Construction Works LTD to provide a drilling services leading to the construction of two boreholes at the site of the Komenda Sugar Factory. Based on the results, air lift yields of 30L/min were recorded for each of the two boreholes. The results also reveal that the underlain rock formation is Sekondian shale with an average weathering depth of 6m.

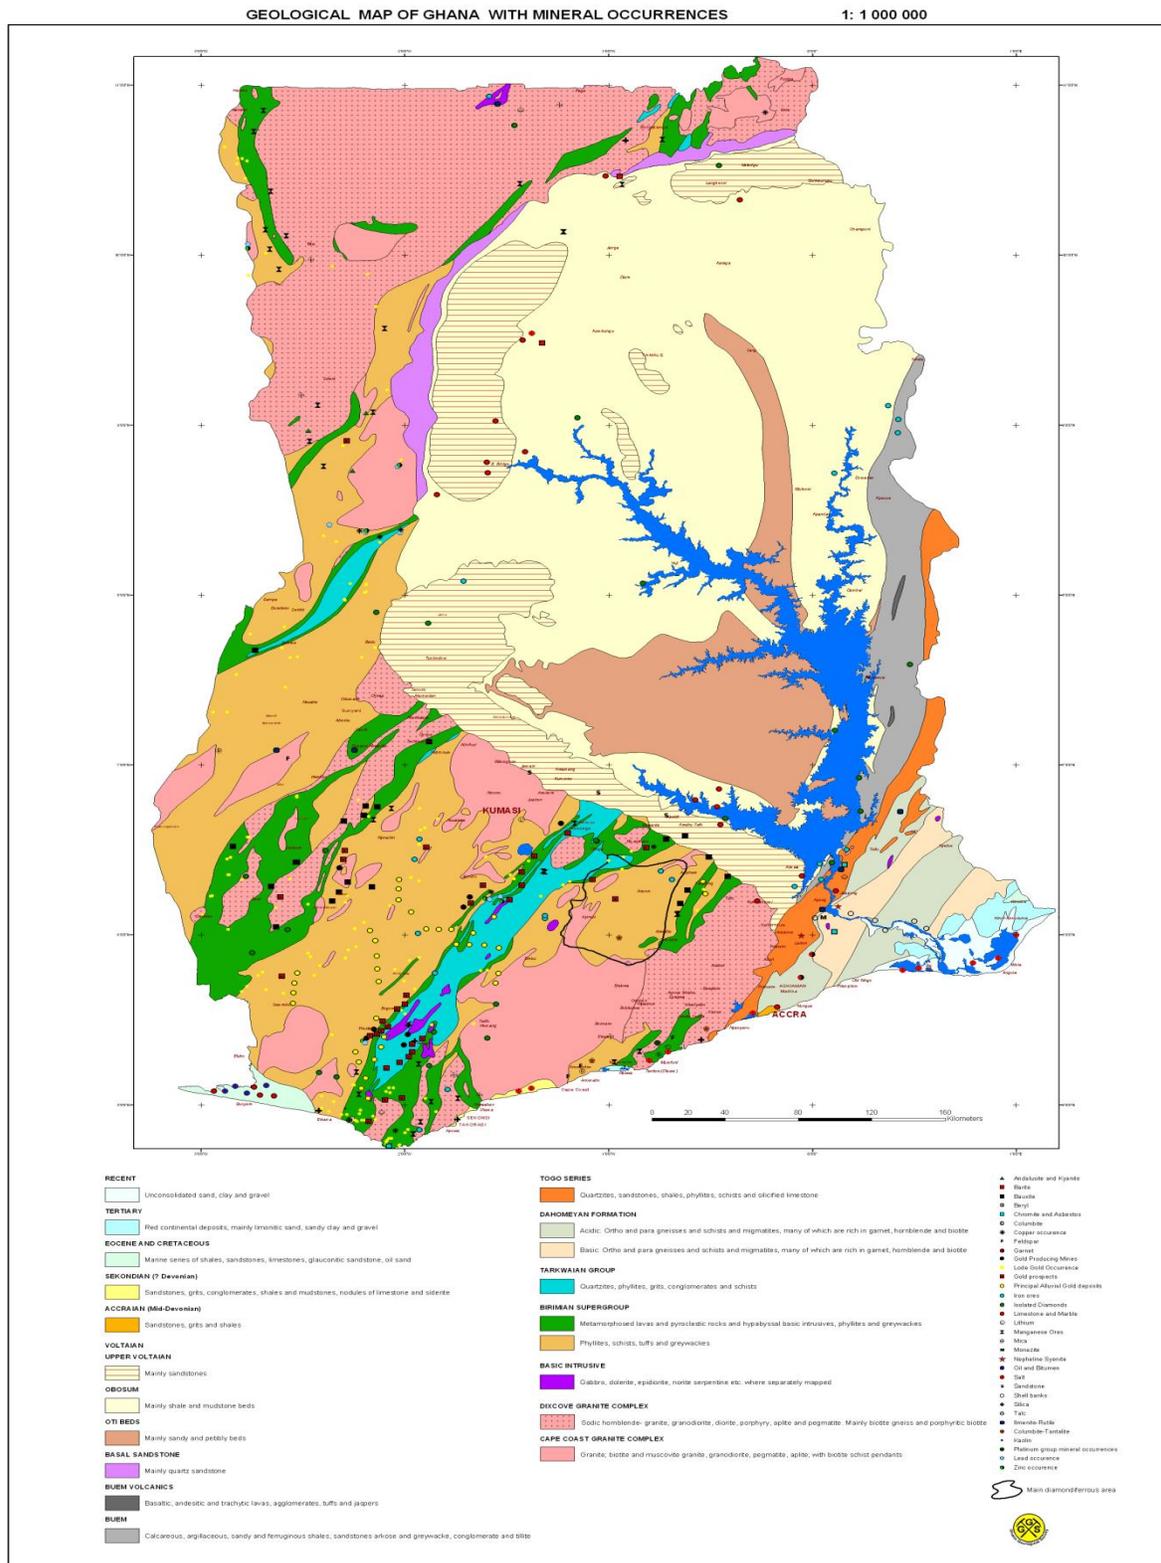
Figure 1: Geological Map of Ghana.

pegmatite and also the Sekondian rocks comprising of shales, sandstone, grits, mudstone and conglomerates. Geologically, the project site is underlain by shale which is shown on figure 1 which represent the geological map of Ghana.

The shale is among the least yielding formations in Ghana in terms of groundwater exploitation. In view of the difficulty of the area as far as locating good aquifers are concerned, it is the suggestion of Pekwapong Company Limited that Hydrofracturing should be included in the subsequent projects to improve the success rate. The water quality in some part of the municipality is normally characterised by presence of concentration of salt and iron.
